**AVIATION INVESTIGATION REPORT  
A04H0004**

**REDUCED POWER AT TAKE-OFF AND COLLISION WITH  
TERRAIN**

**MK AIRLINES LIMITED  
BOEING 747-244SF 9G-MKJ  
HALIFAX INTERNATIONAL AIRPORT, NOVA SCOTIA  
14 OCTOBER 2004**

Report Number A04H0004

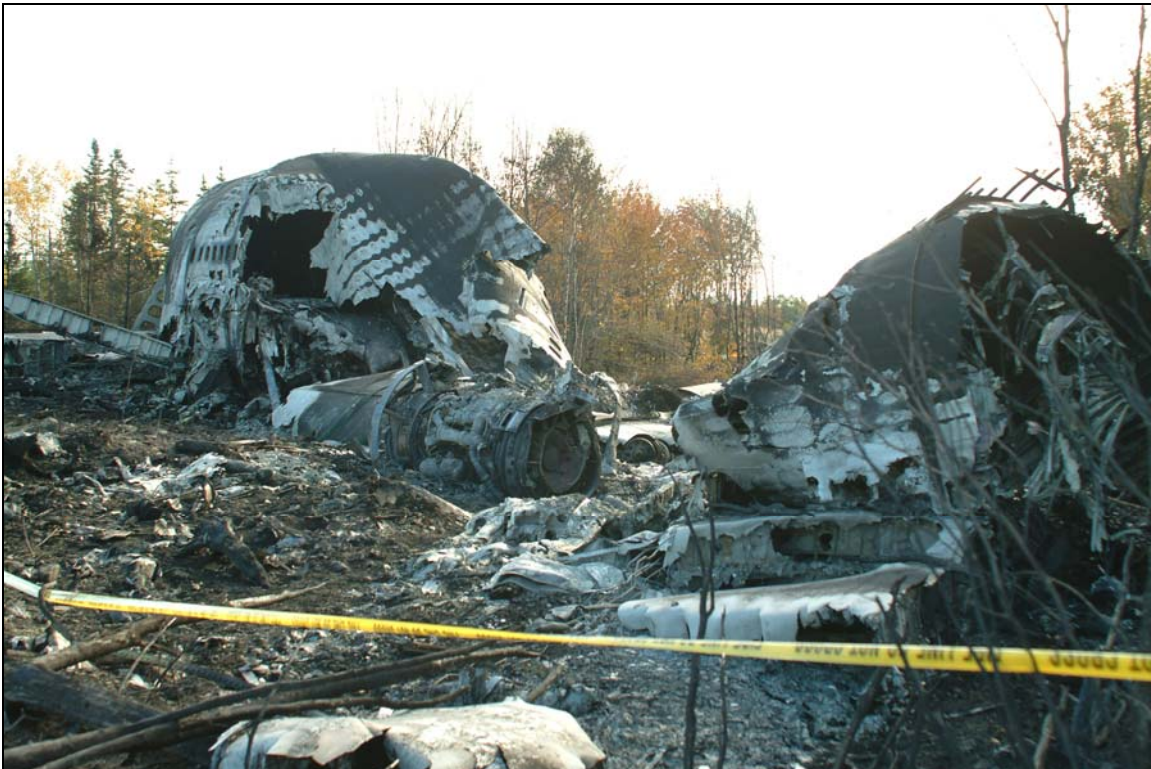
The first damage to the aircraft occurred when, on rotation, the aircraft's lower aft fuselage struck the runway twice and remained on the ground to a point 825 feet beyond the end of Runway 24. Severe damage occurred when the aircraft's lower aft fuselage struck the berm and the vertical stabilizer and both horizontal stabilizers separated from the fuselage. The final impact was in a wooded area where impact forces and an extensive post-crash fire destroyed the remaining aircraft structure forward of the aft pressure bulkhead (see Photo 1).

**Photo 1.** Main fuselage and number 4 engine

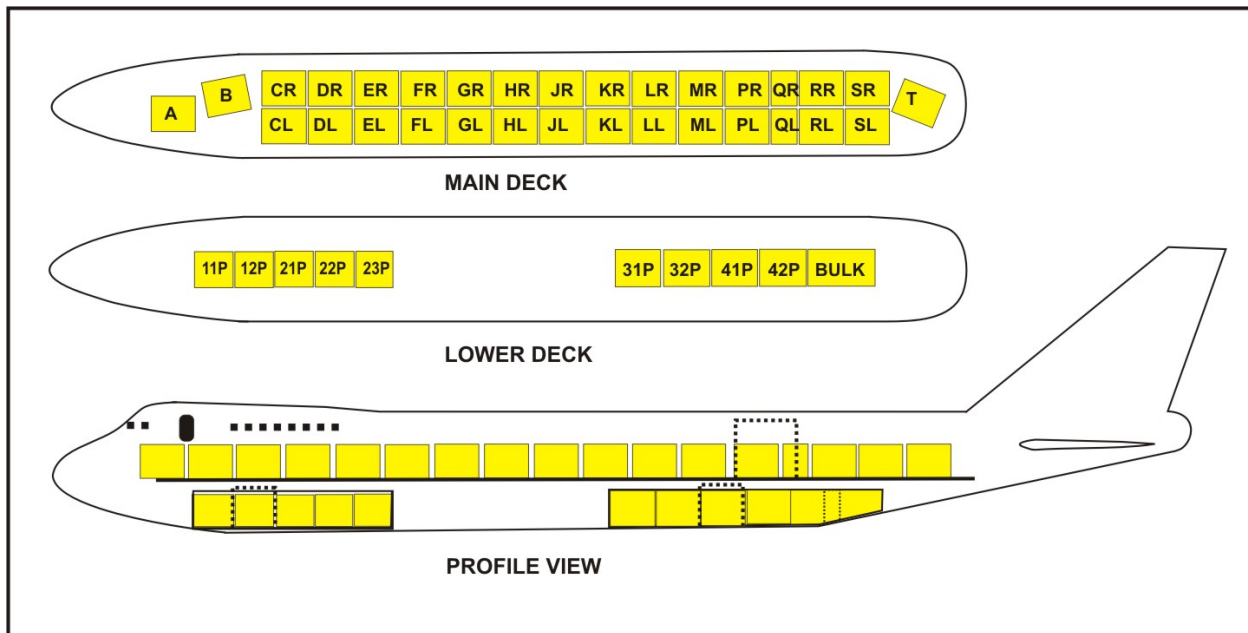
**Figure 1.** Cargo positions

The weight limits for positions LR and MR are 4264 kg respectively, for a total weight limit of 8528 kg. The weight of the steel and the pallet exceeded the limits by 4678 kg. The MK Airlines Limited operations manual (OM), Part A, Chapter 8, stated in part that “the loadmaster/captain must comply with additional structural limits as specified in the loading manual with regard to the maximum mass per cargo compartment.” If all the PDUs had been serviceable, the steel load could have been properly placed in positions HR and JR, where the limit was 13 608 kg.

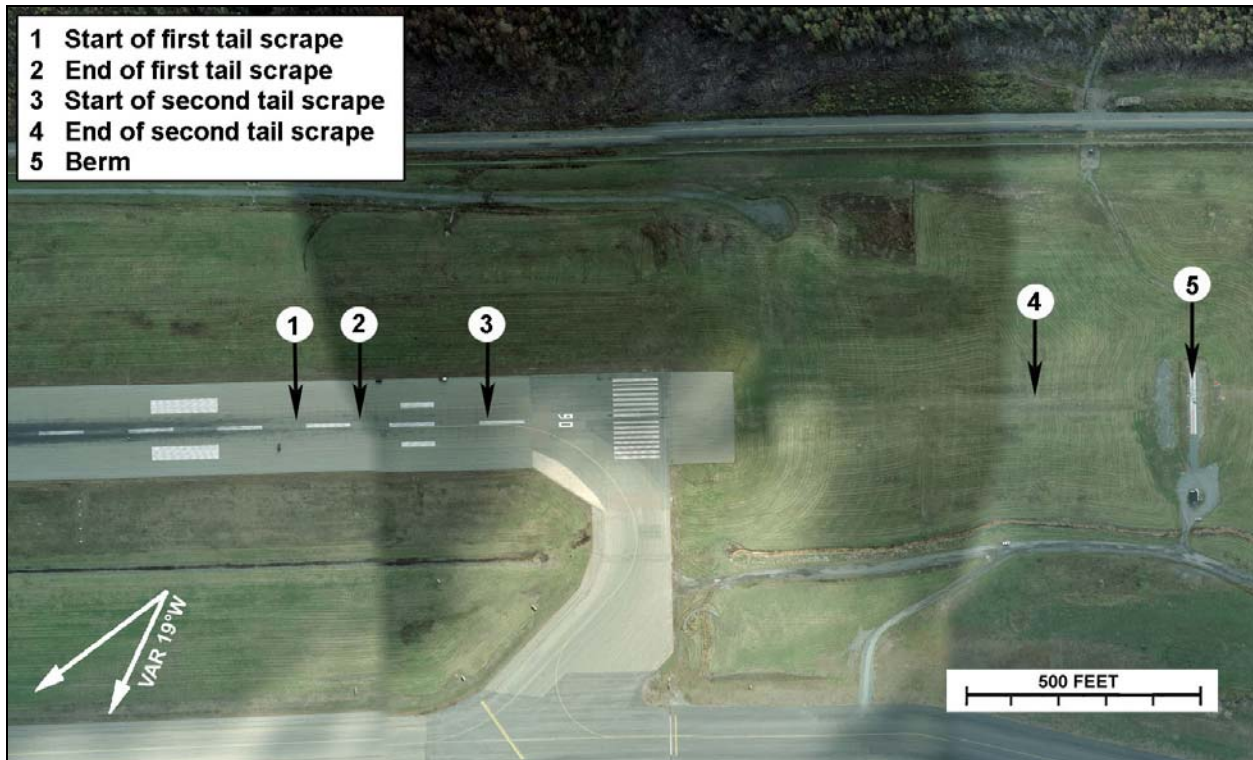
**Photo 2.** Location of scrape marks and berm

The first indication of aircraft contact with the runway was a scrape mark, which began 830 feet before the end of Runway 24 and was 30 inches left of the runway centreline; it became progressively wider, ending 705 feet from the end of the runway. The scrape mark formed a line approximately one-half degree off the centreline toward the left (see Photo 2).

A second scrape mark began 412 feet from the end of the runway and was initially about 3 inches wide, expanding to about 24 inches wide at the runway threshold. There were aluminum scrapes and shavings all along this scrape mark. It continued through the paved runway overrun area and across the grassy area. On the grassy area, the ground scar was initially about 24 inches wide and 2 inches deep, eventually fanning out to about 30 inches wide (see Photo 3). The ground scar became less pronounced until it disappeared at a point approximately 315 feet before the berm, indicating that the aircraft became airborne. The only indication of aircraft contact with the ground was the ground scar caused by the lower aft fuselage. There was no indication that the tires contacted the ground beyond the paved surface. No primary aircraft structure was found in the debris trail before the berm.

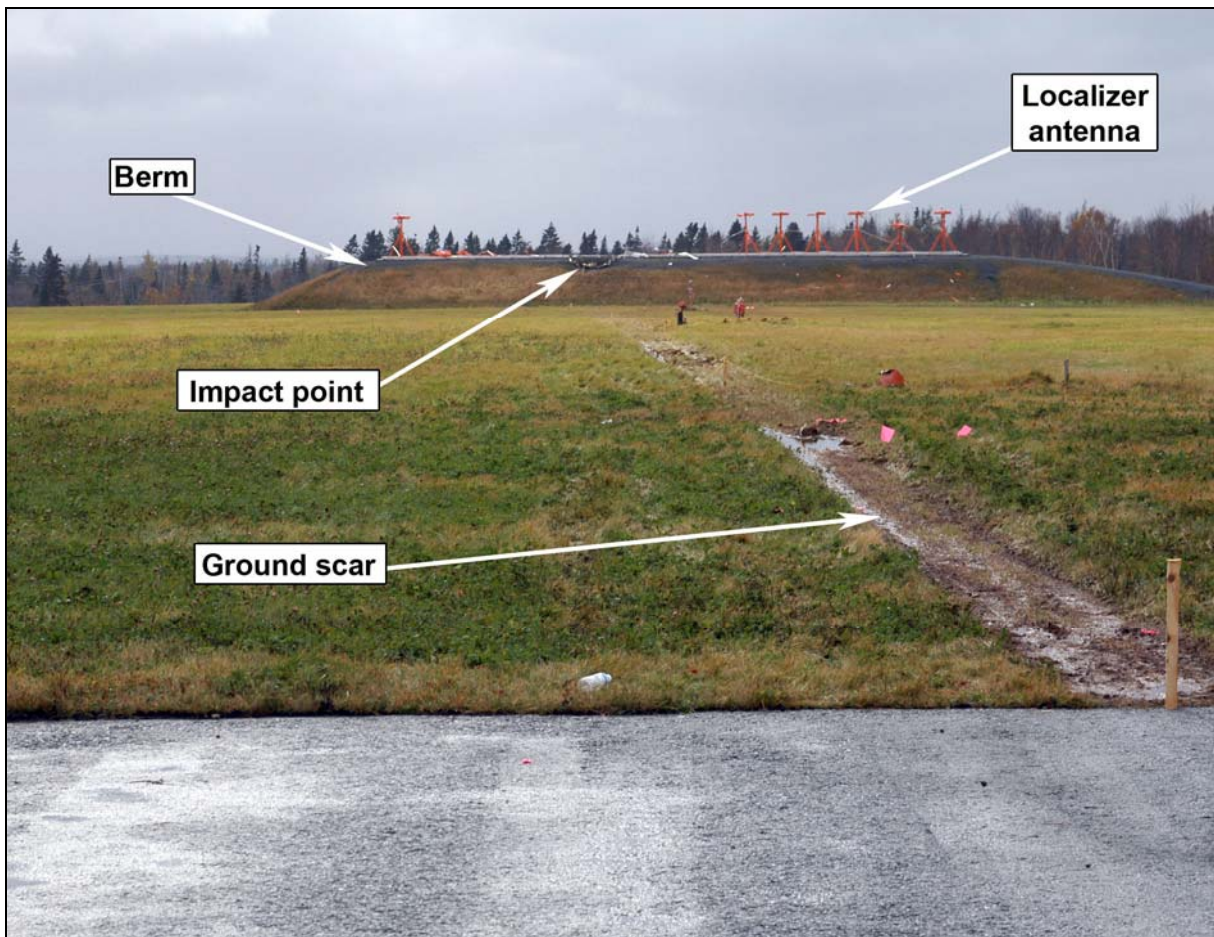
**Photo 3.** View of ground scar and initial impact point with the berm

Fuselage structure, comprising the fuselage joint of the aft pressure bulkhead at Station 2360 and some adjacent belly skin, was found embedded in the berm. These pieces were embedded approximately 18 feet to the left of the extended runway centreline, about 30 inches below the top of the concrete pad, and had penetrated about 24 inches into the berm. Black rubber transfer marks, consistent with aircraft tire contact, were on some of the fractured pieces of the ILS antenna, indicating that the tires had struck the antenna (see Photo 4). No similar marks were observed across the concrete pad on top of the berm, indicating that the tires were above the concrete pad as the aircraft passed over it. The pieces of aircraft belly skin found embedded in the berm were identified as coming from the centreline of the aircraft and included roughly the same amount of structure from each side of the centreline. This is consistent with the aircraft having struck the berm in a roughly wings-level attitude. The aircraft pitch was between 15° and 24° at berm impact. If the aircraft was pitched at less than 15°, the wheels would have struck the top of the berm, and if the aircraft was pitched at greater than 24°, the tires would not have struck the antenna.

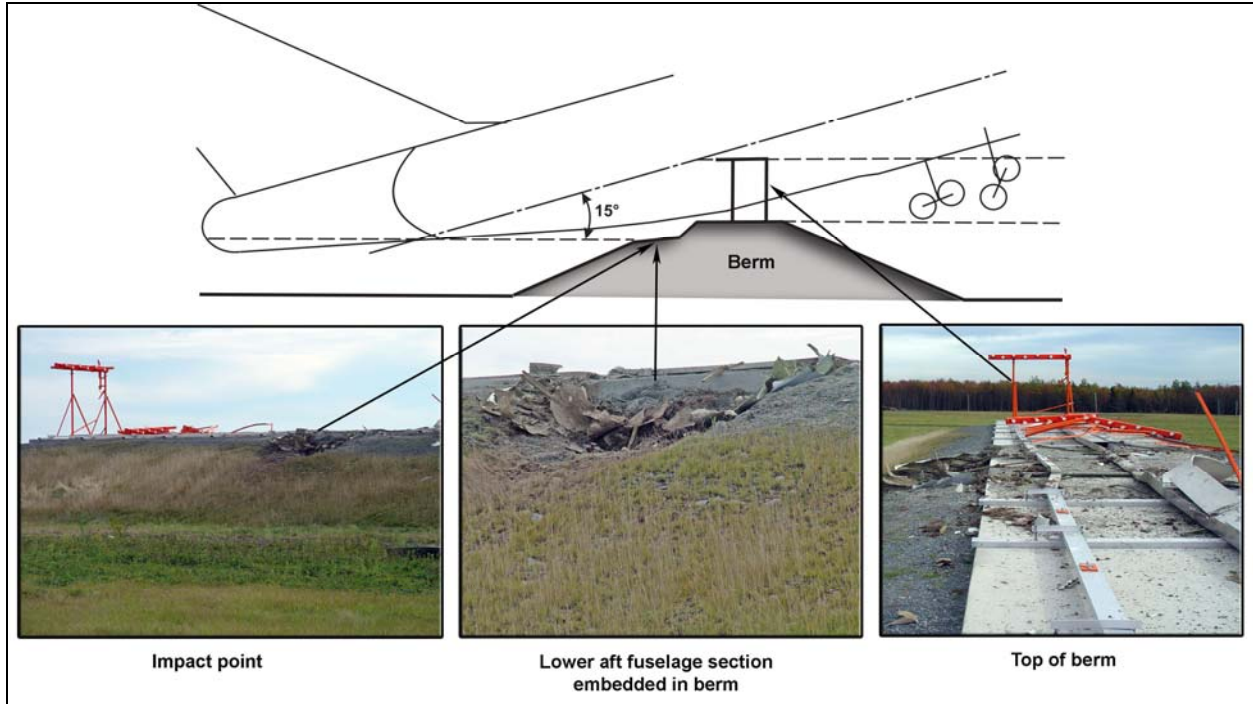
**Photo 4.** Minimum aircraft pitch attitude at point of impact with berm

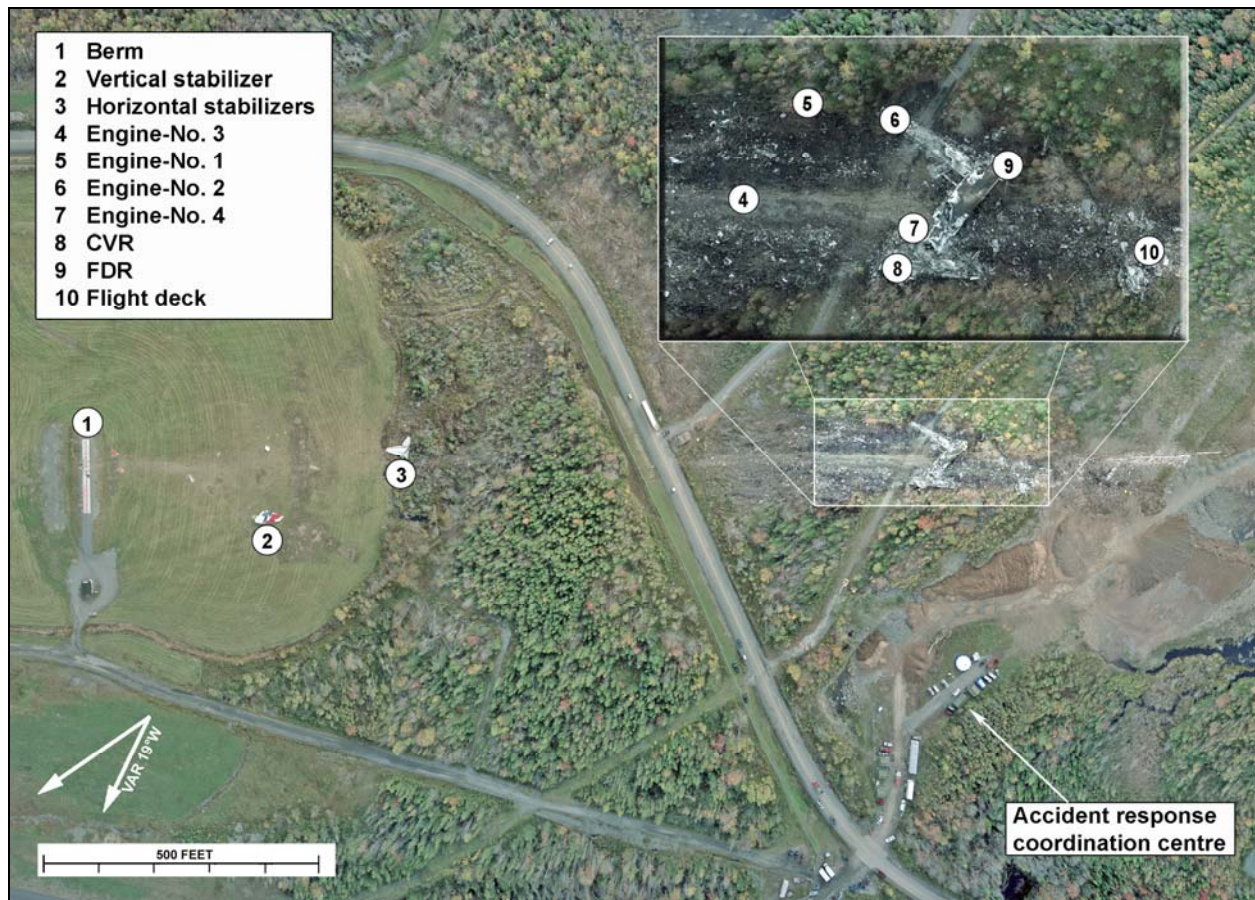
The cockpit voice recorder (CVR) was a Collins model 642C-1, part number 522-4057-010, serial number 1660, that was fitted in March 2004. The CVR was found under debris in its mounting bracket near its installed location (see Photo 5), and it had been exposed to fire and extreme heat for an extended period. The recording tape had melted; consequently, no CVR information was available to investigators. Although this model of recorder was not required to meet the more stringent fire test requirements that exist today, the conditions of extreme heat were such that the likelihood of any tape-based recorder surviving in those conditions is considered very low.

Immediately beyond the berm, there was extensive debris that included the vertical and horizontal stabilizers, a section of aft pressure bulkhead, the tail cone, the auxiliary power unit, and some pieces of aft fuselage belly skin. In the wooded area beyond the berm, there were numerous smaller pieces of aircraft structure and cargo. The debris trail then diminished until the main impact, suggesting that, following the separation of the empennage, the rest of the aircraft remained relatively intact until impact (see Photo 5).

**Photo 5.** Accident site and wreckage location

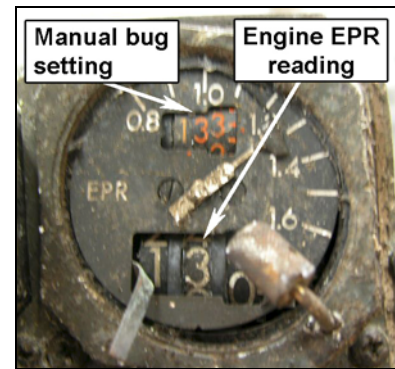
The number 2, number 3 and number 4 EPR gauges were recovered and examined. The number 2 EPR gauge had a manual bug setting of 1.32 and an engine indication reading of 1.01; the number 3 EPR gauge had a manual bug setting of 1.3X (the last digit had broken off at impact) and an engine indication reading of 1.02; and the number 4 EPR gauge (see Photo 6) had a manual bug setting of 1.33 and an engine indication reading of 1.305. The EPR settings on the three recovered instruments were set to 1.32–1.33. These readings were considered to be reliable, with the slight differences attributed to movement during the impact sequence.

**Photo 6.** Engine number 4 EPR gauge
